Title: The renovation of the bird gallery at The Manchester Museum Conservation aspects

Author(s): Horie, C. V.

Source: Horie, C. V. (1983). The renovation of the bird gallery at The Manchester Museum Conservation aspects. *Biology Curators Group Newsletter*, Vol 3 No 6, 331 - 338.

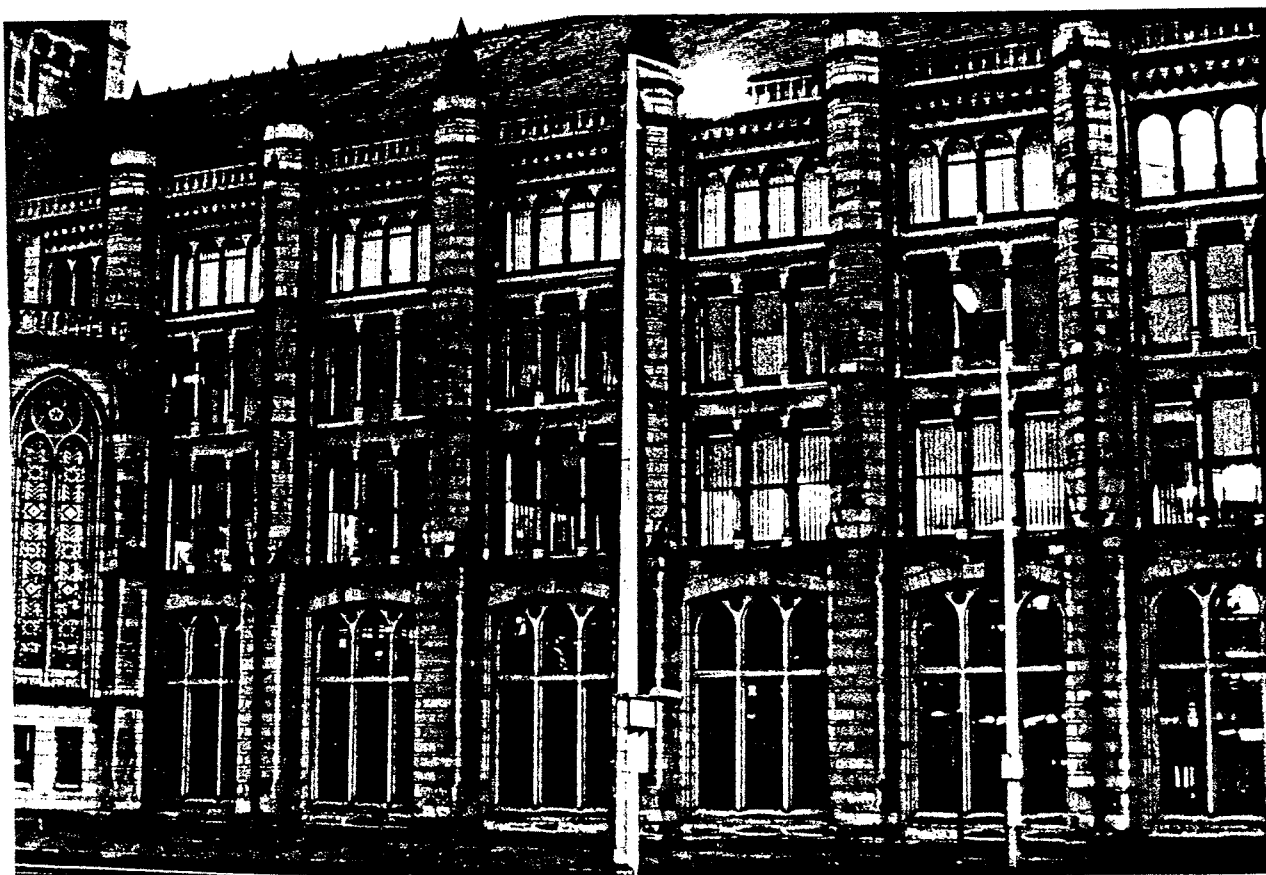
The gallery was originally designed to be lit by natural light, supplemented by gas flares (fig.2). Accordingly the cases are set in bays between the windows along the gallery with skylights down the centre to illuminate the well. Obvious damage had occurred to the specimens by the action of daylight and sunlight which had streamed in over many years. Although in the late nineteenth century and early 1900's roller blinds were used on the windows to control the light, these had long since been removed. The skylights had in recent years been treated with a light reflecting film (Scotchint) but this film is inadequate as it keeps falling off due to the action of water condensed on the glass. It is proposed to obscure the skylights completely in the near future. The use of solar control films on the windows of the gallery was investigated (3) but rejected as the achievable light reduction would not be deflected. Dark coloured vertical blinds (Permaglass) were chosen to deal with these problems. Unfortunately blinds are more vulnerable to wear and vandalism so providing problems in long-term maintenance. The blinds, which have been placed over all the windows in the natural history galleries, have reduced the ambient light levels to be used to illuminate the specimens adequately. The iron-framed windows in the gallery were repaired and gasketed to reduce leakages of the outside air which carries pollution.

1;  
External view of the natural science galleries after  
renovation. The three top floors make up the natural  
history galleries, the bird gallery being the middle of the  
three. The effects of the blinds are visible as is the  
obviously lower light level in the bird gallery.

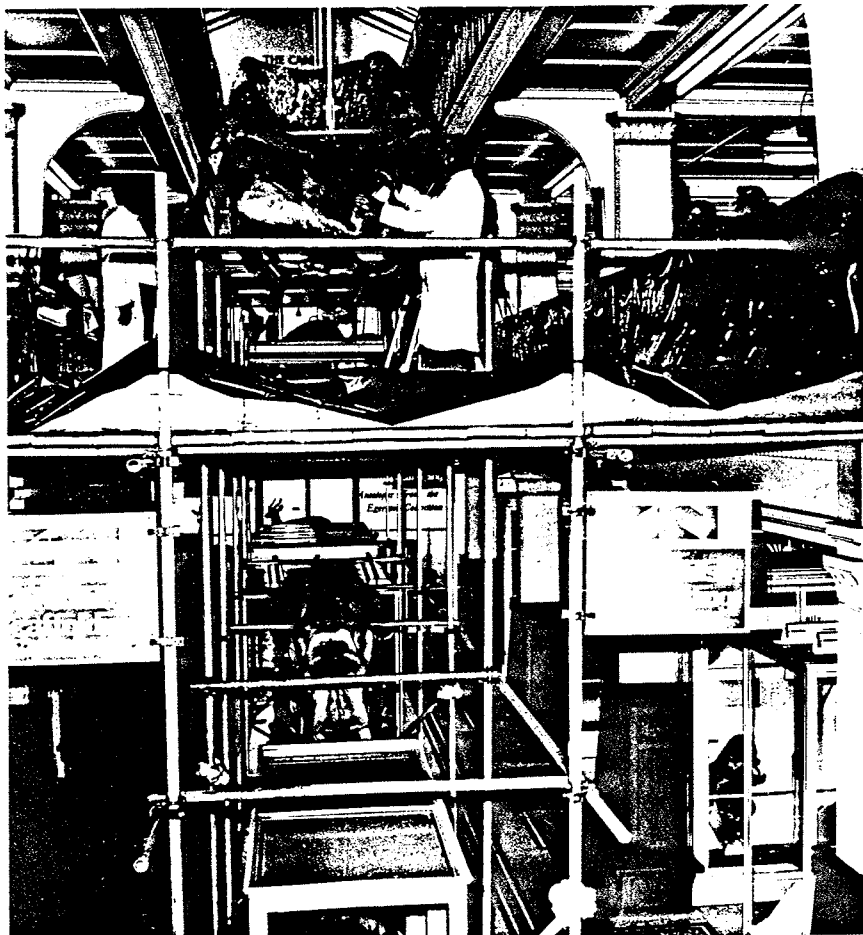
3;  
Whale washing. Also visible is the fluorescent lighting used before the renovation.

- 6) Dirty bird eggs were cleaned with Synperonic solution.
- 7) The whale skeleton posed greater logistical problems. Scaffolding was erected (fig.3) and the skeleton was vacuum cleaned then scrubbed down with a mixture of 1% Synperonic, 2% .880 ammonia and 10% IMS in water. The detergent mixture was rinsed out by spraying with water from a high pressure portable plant spray. The rinsing was repeated until the water ran out of the bone clear. After drying for two weeks the bone was coated with two coats of a 10% solution of poly vinyl butyral (Mowital) in IMS.
