Title: The renovation of the bird gallery at The Manchester Museum Conservation aspects

Author(s): Horie, C. V.

Source: Horie, C. V. (1983). The renovation of the bird gallery at The Manchester Museum Conservation aspects. *Biology Curators Group Newsletter*, Vol 3 No 6, 331 - 338.

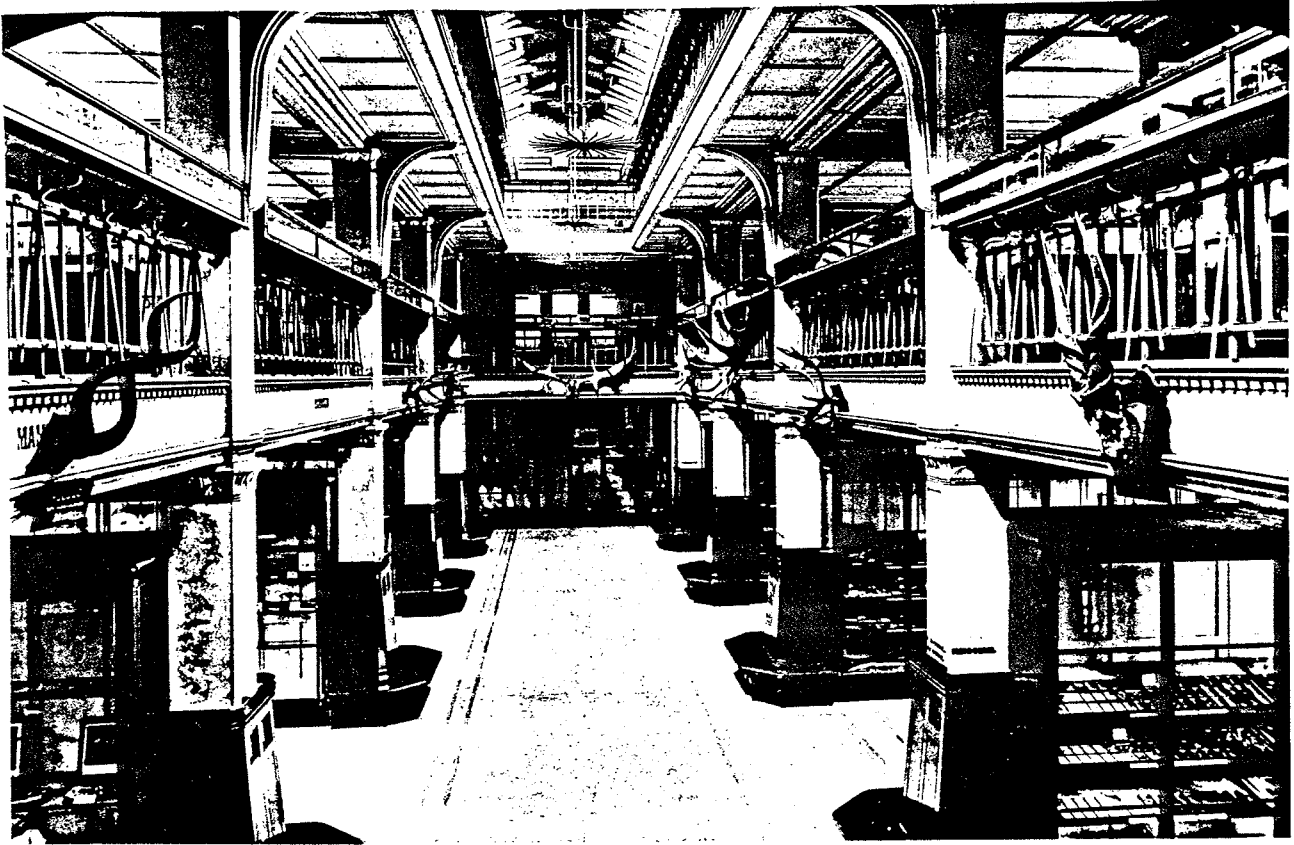
The gallery was originally designed to be lit by natural light, supplemented by gas flares (fig.2). Accordingly the cases are set in bays between the windows along the gallery with skylights down the centre to illuminate the well. Obvious damage had occurred to the specimens by the action of daylight and sunlight which had streamed in over many years. Although in the late nineteenth century and early 1900's roller blinds were used on the windows to control the light, these had long since been removed. The skylights had in recent years been treated with a light reflecting film (Scotchint) but this film is inadequate as it keeps falling off due to the action of water condensed on the glass. It is proposed to obscure the skylights completely in the near future. The use of solar control films on the windows of the gallery was investigated (3) but rejected as the achievable light reduction would not be deflected. Dark coloured vertical blinds (Permaglass) were chosen to deal with these problems. Unfortunately blinds are more vulnerable to wear and vandalism so providing problems in long-term maintenance. The blinds, which have been placed over all the windows in the natural history galleries, have reduced the ambient light levels to be used to illuminate the specimens adequately. The iron-framed windows in the gallery were repaired and gasketed to reduce leakages of the outside air which carries pollution.

2;  
View of the galleries in the late nineteenth century showing arrangement of cases in bays between windows.
